### **CCW IMPOUNDMENTS INSPECTION REPORT**

#### **ROXBORO STEAM ELECTRIC PLANT PERSON COUNTY, NORTH CAROLINA**

**PROJECT NO. 09-4157**  
**OCTOBER, 2009**

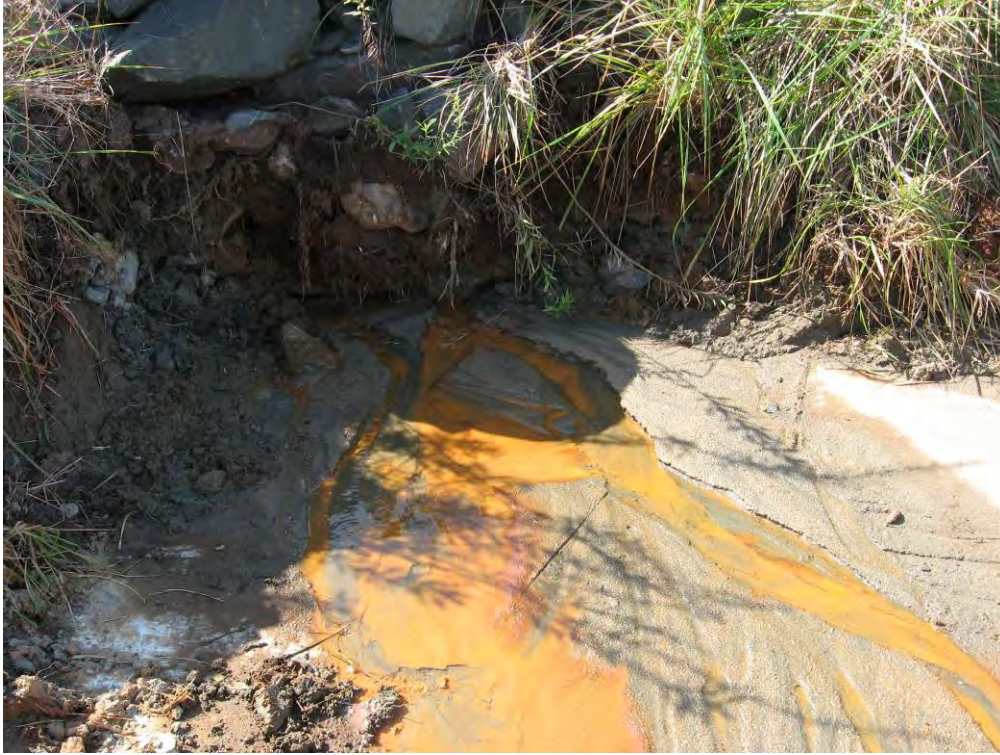
Seepage water was clear with orange stain typical of flow from dam drainage systems in the Piedmont region. Two drains that were seeping had developed deltas of sand size materials possibly indicative of transport of fine filter material. The deltas could also be from local erosion due to the clean-out operation. The drains should be observed during the weekly inspections to determine if material is being transported from within the dam. A method to quantify the amount of seepage from each outlet is recommended.

**PHOTO 3: CHIMNEY DRAIN AT TOE OF WEST ASH POND DAM**

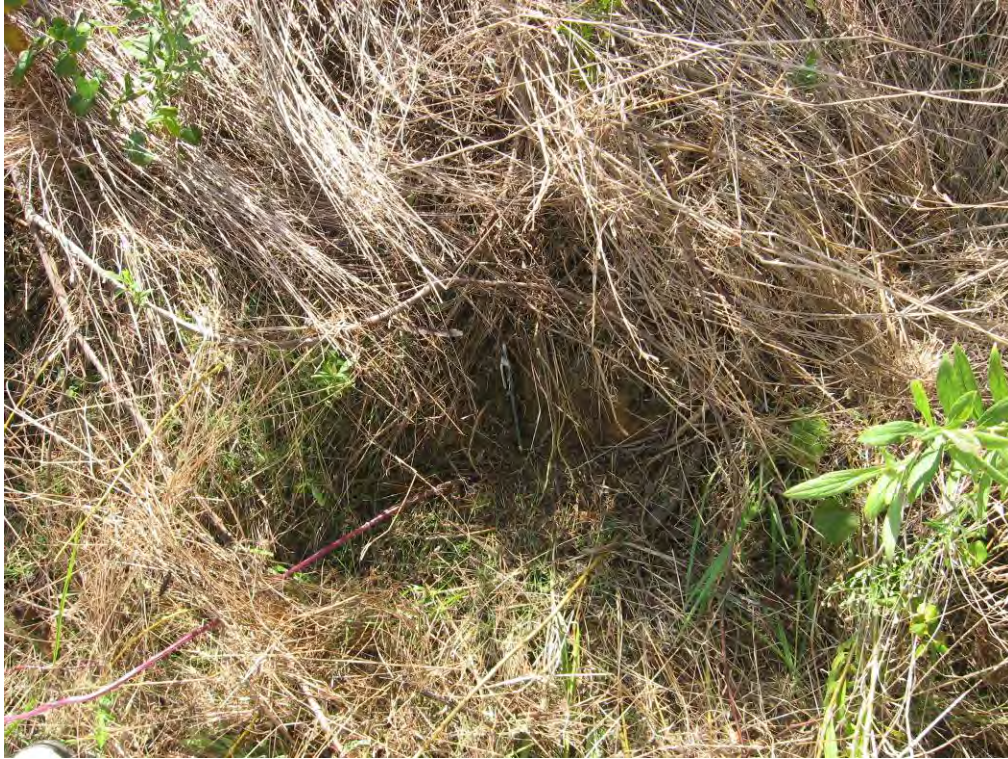
**PHOTO 5: SMALL SCARP LOCATED BETWEEN SECOND AND THIRD  
DRAIN OUTLETS OF WEST ASH POND DAM**

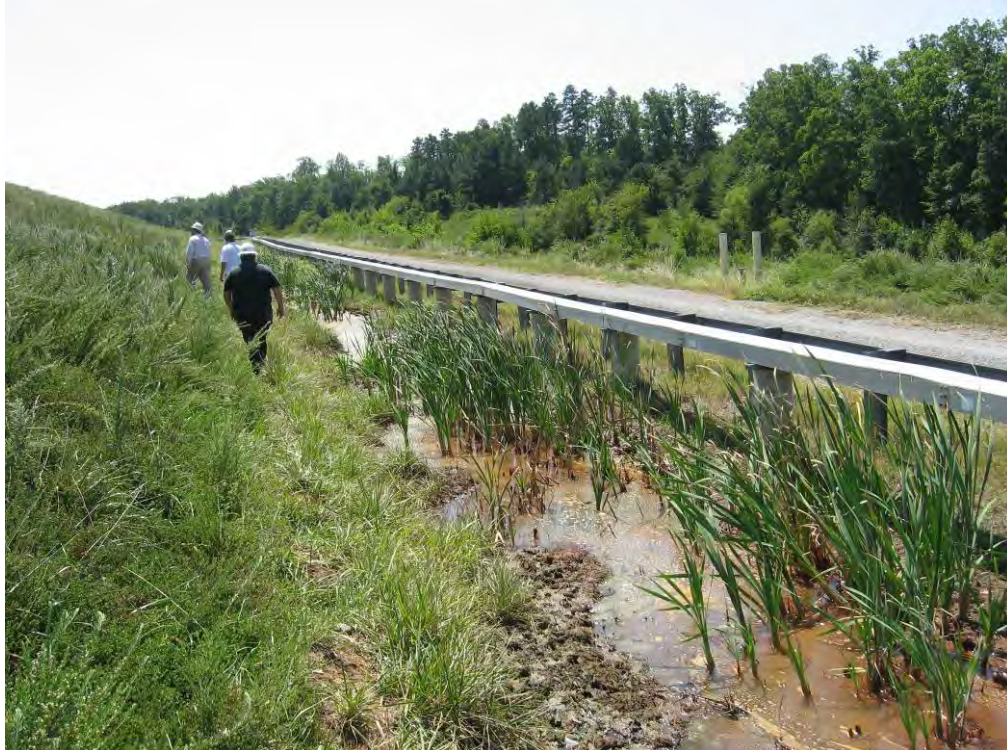
Seepage is present along the toe of the exterior slope. See *Photo 12, Appendix A*. This seepage is carried in a toe ditch to a sump where it is pumped back into the pond. Seepage is generally clear; however small boils and deposits of fines indicate that piping of materials is occurring. (*Photo 14, Appendix A*). Monitoring of the seepage should be continued until the repairs are initiated.

**PHOTO 12: TOE OF FGD SETTLING POND (LOOKING S)**

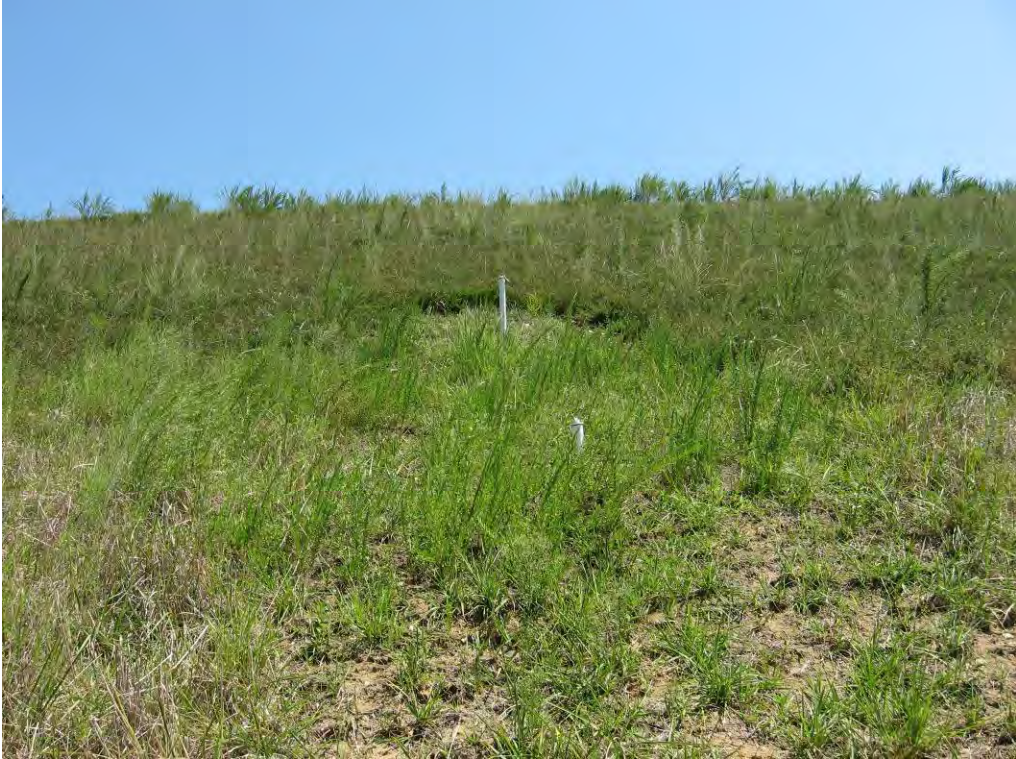
The crest of the structure has a hard surface that is relatively new and showed no signs of cracking, settlement or rutting. The interior slope is covered by riprap and appeared to be uniform with no sloughing, bulging, or scarps. The exterior slope is generally uniform and well grassed with the exception of isolated sloughs that had been patched following the seepage event. See *Photo 13, Appendix A*.

**PHOTO 13: DOWNSTREAM EMBANKMENT OF FGD SETTLING POND**

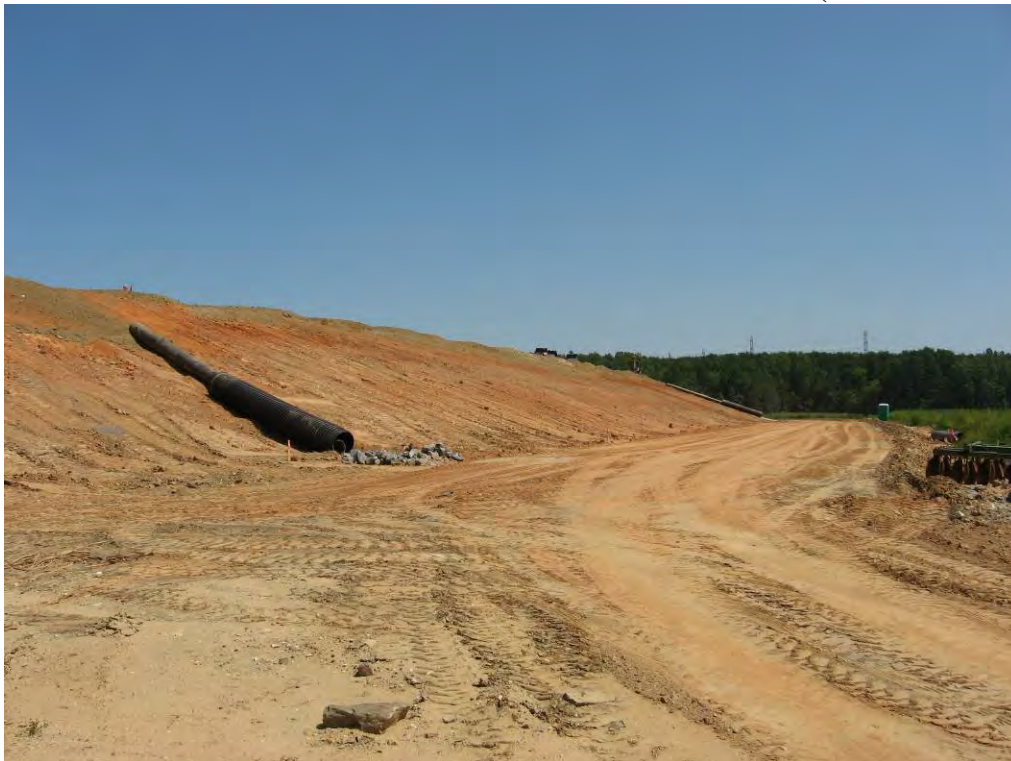
The Flush Pond is currently under construction. It was taken out of service in February 2008 when a piping failure occurred that resulted in the development of a slough in both the inside and outside slopes.

**PHOTO 16: DOWNSTREAM TOE OF FGD FLUSH POND (LOOKING NE)**

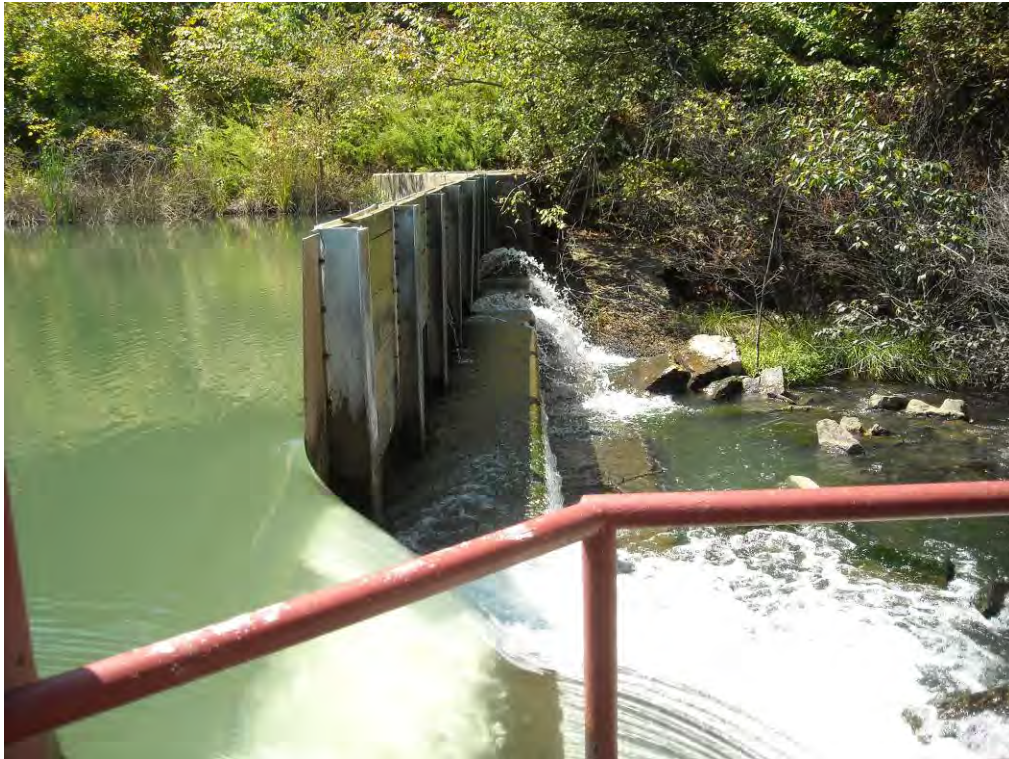
The discharge weir structure is the NPDES Permit NC-0003425 discharge point. (See *Photo 27, Appendix A*). At the time of inspection clear water was freely flowing from the canal to Hyco Lake. Significant seepage was noted flowing from beneath the concrete abutment on the right (East) side of the structure. The flow appears to be coming through the rock foundation. The *2007 Report of Limited Field Inspection* by MACTEC noted this concern and offered assistance in developing and implementing a repair plan for the condition. RIZZO recommends that this action be taken along with monitoring the flow on a monthly basis concurrent with existing scheduled inspections.

**PHOTO 27: CLOSE UP OF WEST ASH POND DAM DISCHARGE WEIR  
STRUCTURE**
